Sperry Marine

PRODUCT ADVISORY NOTICE

Ref: PAN 21/01

Product line: VisionMaster

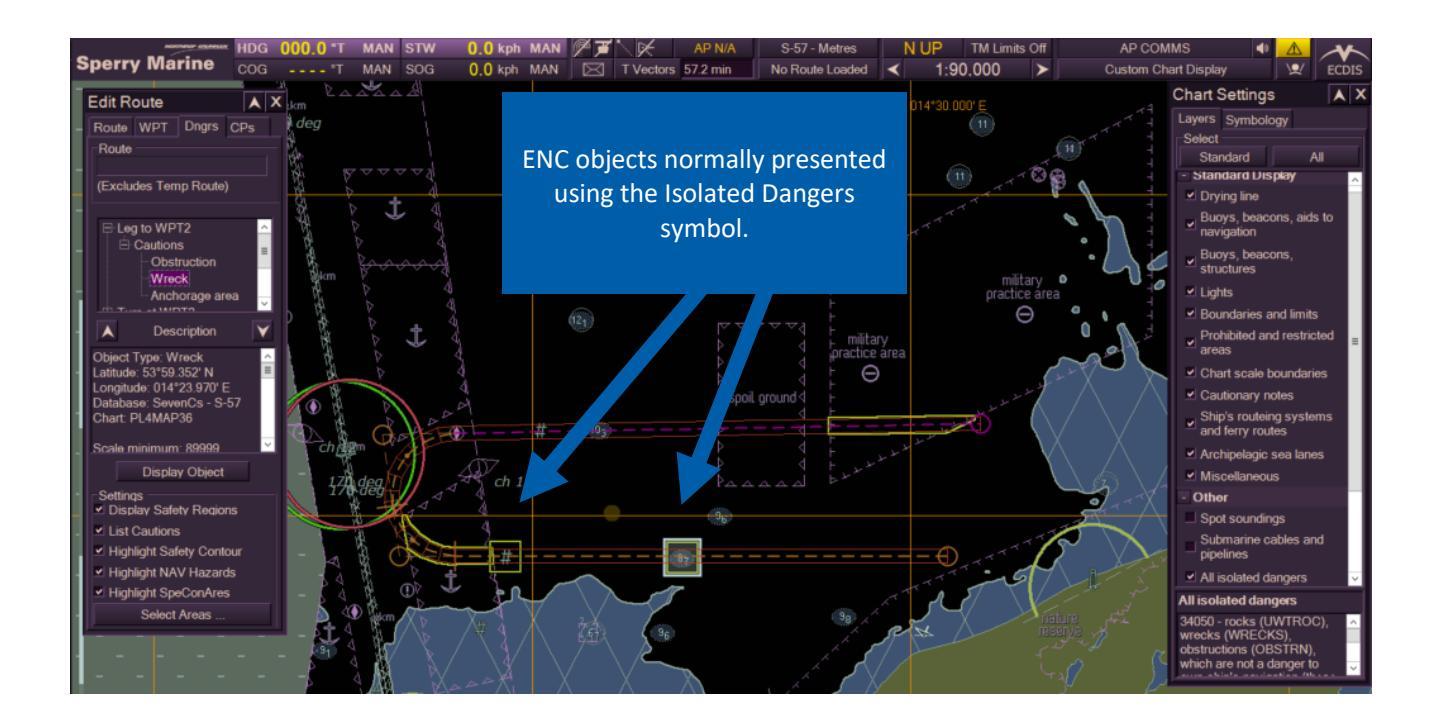
- No symbol is presented when an Isolated Danger symbol should be presented
- A different symbol is presented in place of an Isolated Danger symbol (e.g. a sounding or a wreck symbol)

- The **highlight symbol** (a yellow square) will correctly provide a visual indication of the Navigational Hazard when Route Planning and Route Monitoring
- The correct **Navigational Hazard alert** will be raised while Route Monitoring. This alert will be visual and audible if the mariner has selected Warning priority, and visual only if the mariner has selected Caution priority
- When presented, the underwater object can be **queried (cursor pick)** to determine its depth attributes

The visual effect on the display will vary depending on a number of factors, including the mariner setting of the Safety Depth and the data encoded within the charted object. The image below provides an example of how the affected objects may be presented on an ECDIS during the Route Planning task. In the image, both ENC objects are presented, but a Wreck and a Sounding symbol are shown in place of the Isolated Water Danger. Note that both symbols are correctly highlighted as a Navigational Hazard. The effect is similar during Route Monitoring.

If you are affected by this Product Advisory Notice, Annex A provides guidance and Sperry Marine's recommendation on how to be aware of the Navigational Hazard and to revise vessel operating procedures during the period before the IHO's action takes effect.

Additionally, the next software release of all currently supported VisionMaster products will incorporate an update that prevents a recurrence of the issue. End users are recommended to incorporate this update into their maintenance schedules.
